**DOCUMENTATION OF RIPARIAN AND WILDLIFE  
IMPACTS FROM CONSTRUCTION OF THE LOWER  
CRYSTAL RIVER RECREATIONAL TRAIL,  
GARFIELD AND PITKIN COUNTIES**

**Draft Report by the  
Crystal River Caucus  
Trail Task Force**

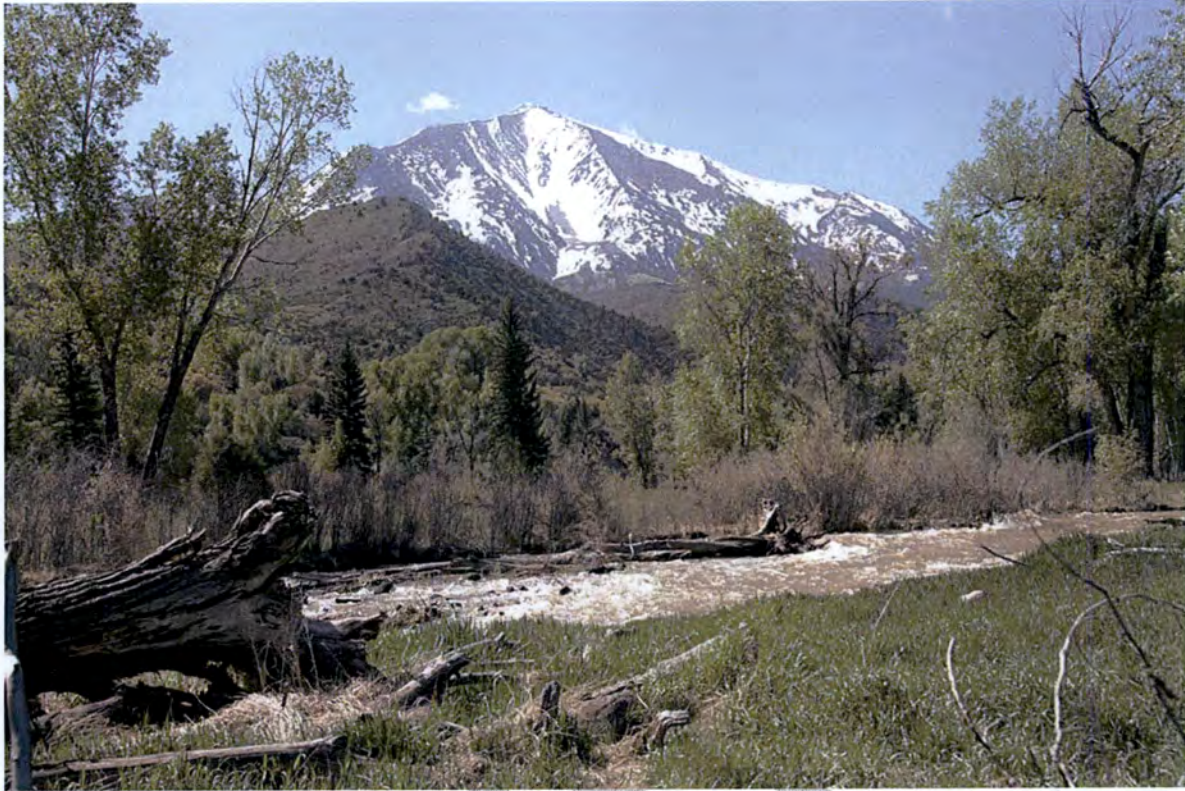
*Figure 1. The lower Crystal River downstream of BRB. September 19, 2009*

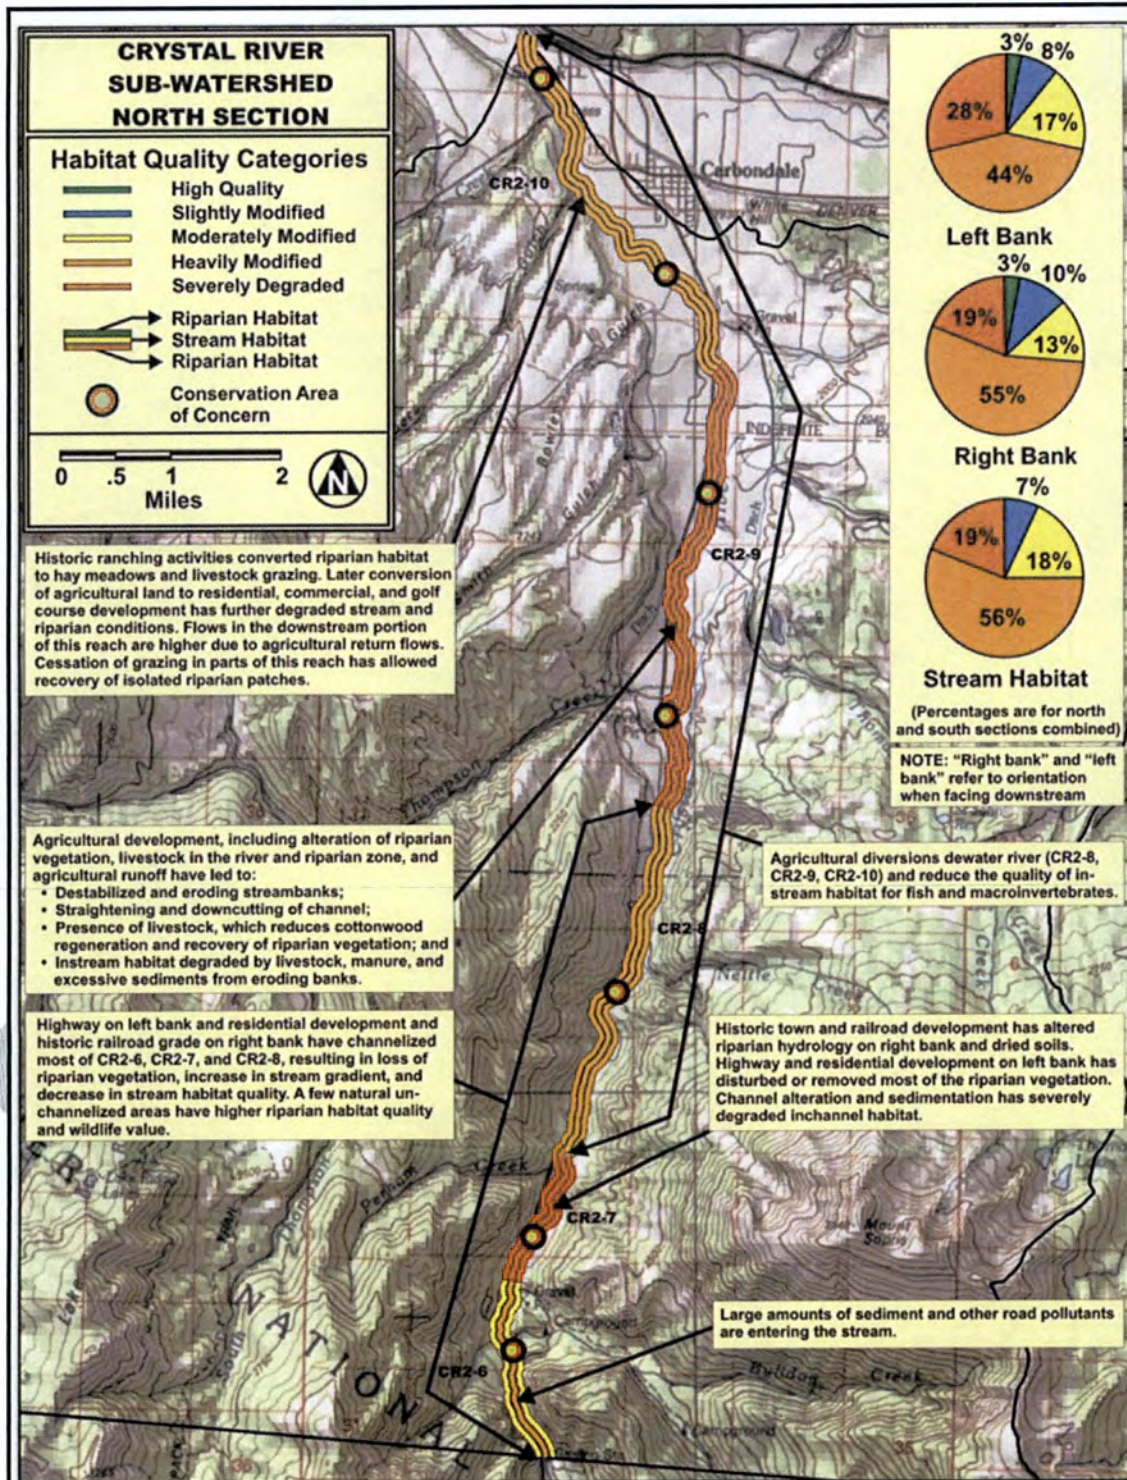
Figure 2. Crystal River Habitat Quality Categories (State of the Roaring Fork Watershed Report, 2008)

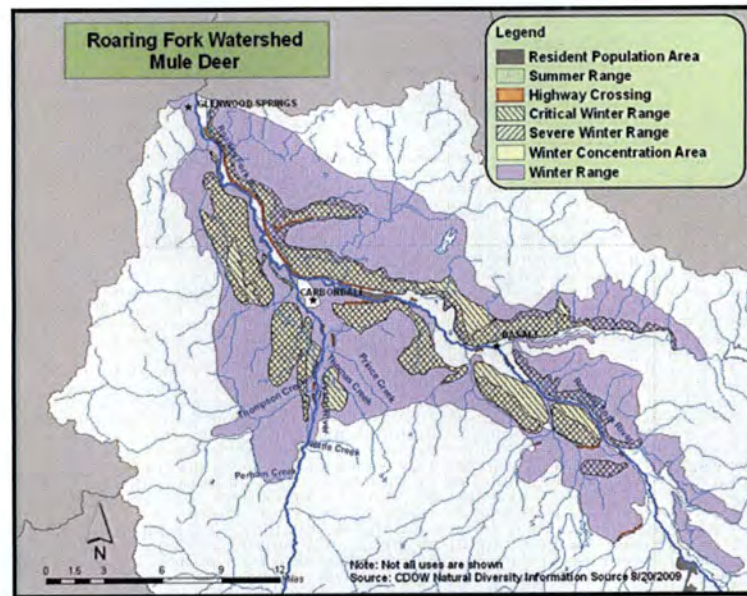
Figure 5. Mule Deer Habitat Map.

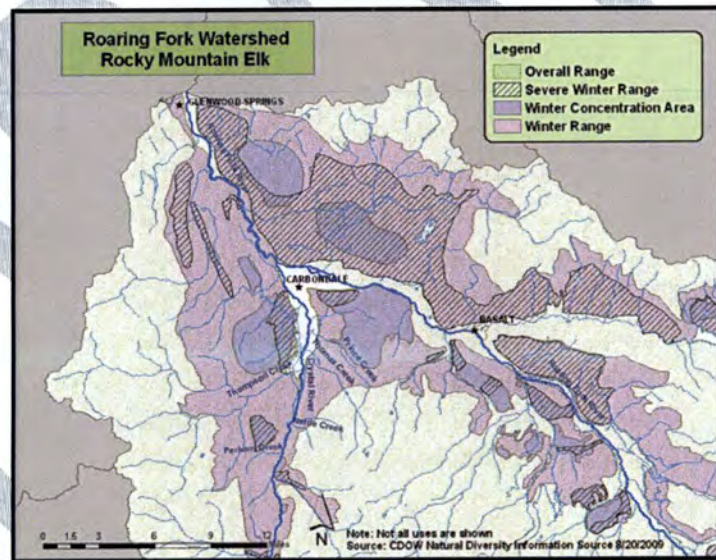
Figure 6. Elk Habitat Map

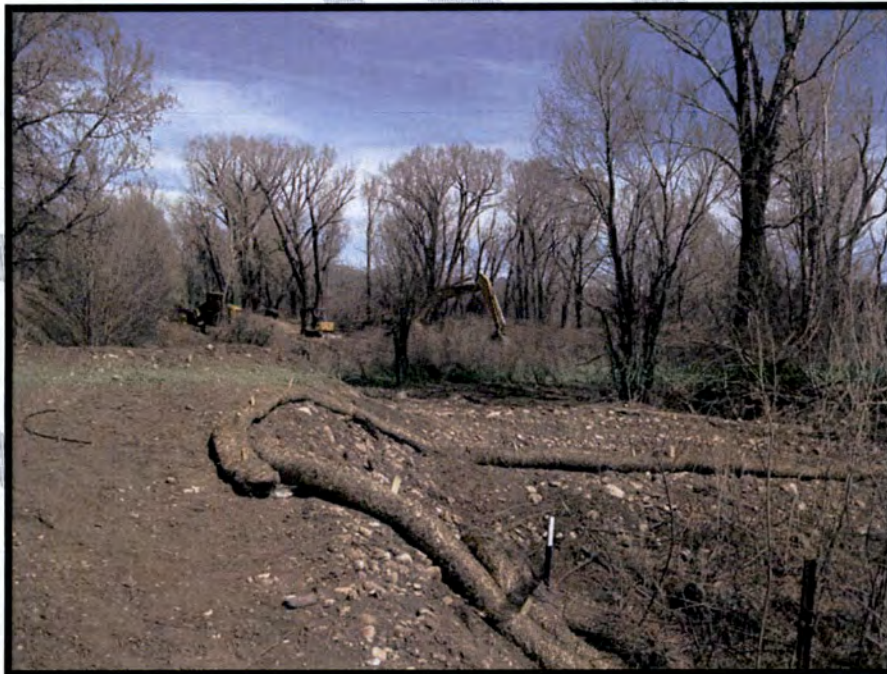
Photo 13. Table 4, Units 1 and 2; Table 1, Unit 10; (EES wetland report Figure 10). The wetland is 0.47 acre at north end of field. Extensive excavation was done in the wetland to create the trail and install irrigation pipe to replace the ditch. Although replacing the ditch with a pipeline is a more efficient way to transport water for agriculture it dewateres the wetland that was previously recharged by the ditch. Wetland habitats are very limited in the lower Crystal River Valley; the few wetlands that exist provide valuable wildlife habitat.

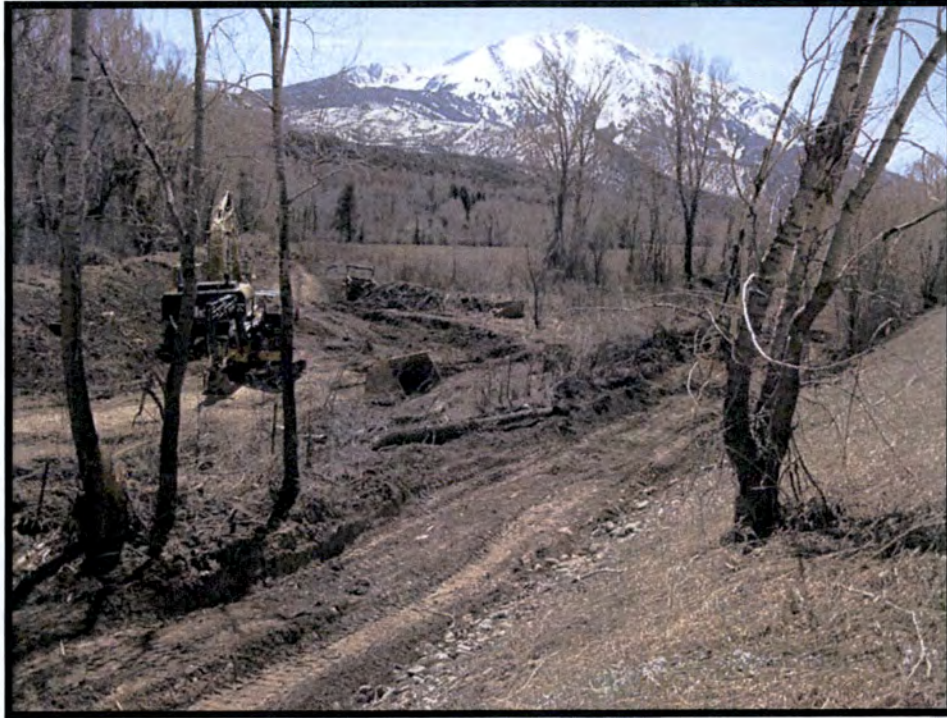
Photo 14. Table 4, Unit 1; Table 1, Unit 10. Looking at wetland from the trail prism.
